U.S. ARMY CORPS OF ENGINEERS NEW ORLEANS DISTRICT	
Submitted:	DR, SP
Reviewed:	ATL
Checked:	TAF
Approved:	Chief, Waterways Maintenance Section

VERMILION RIVER
3 MILE CUT
VM_16_3MC_20150422
22 April 2015

Sheet Reference Number
16 of 49

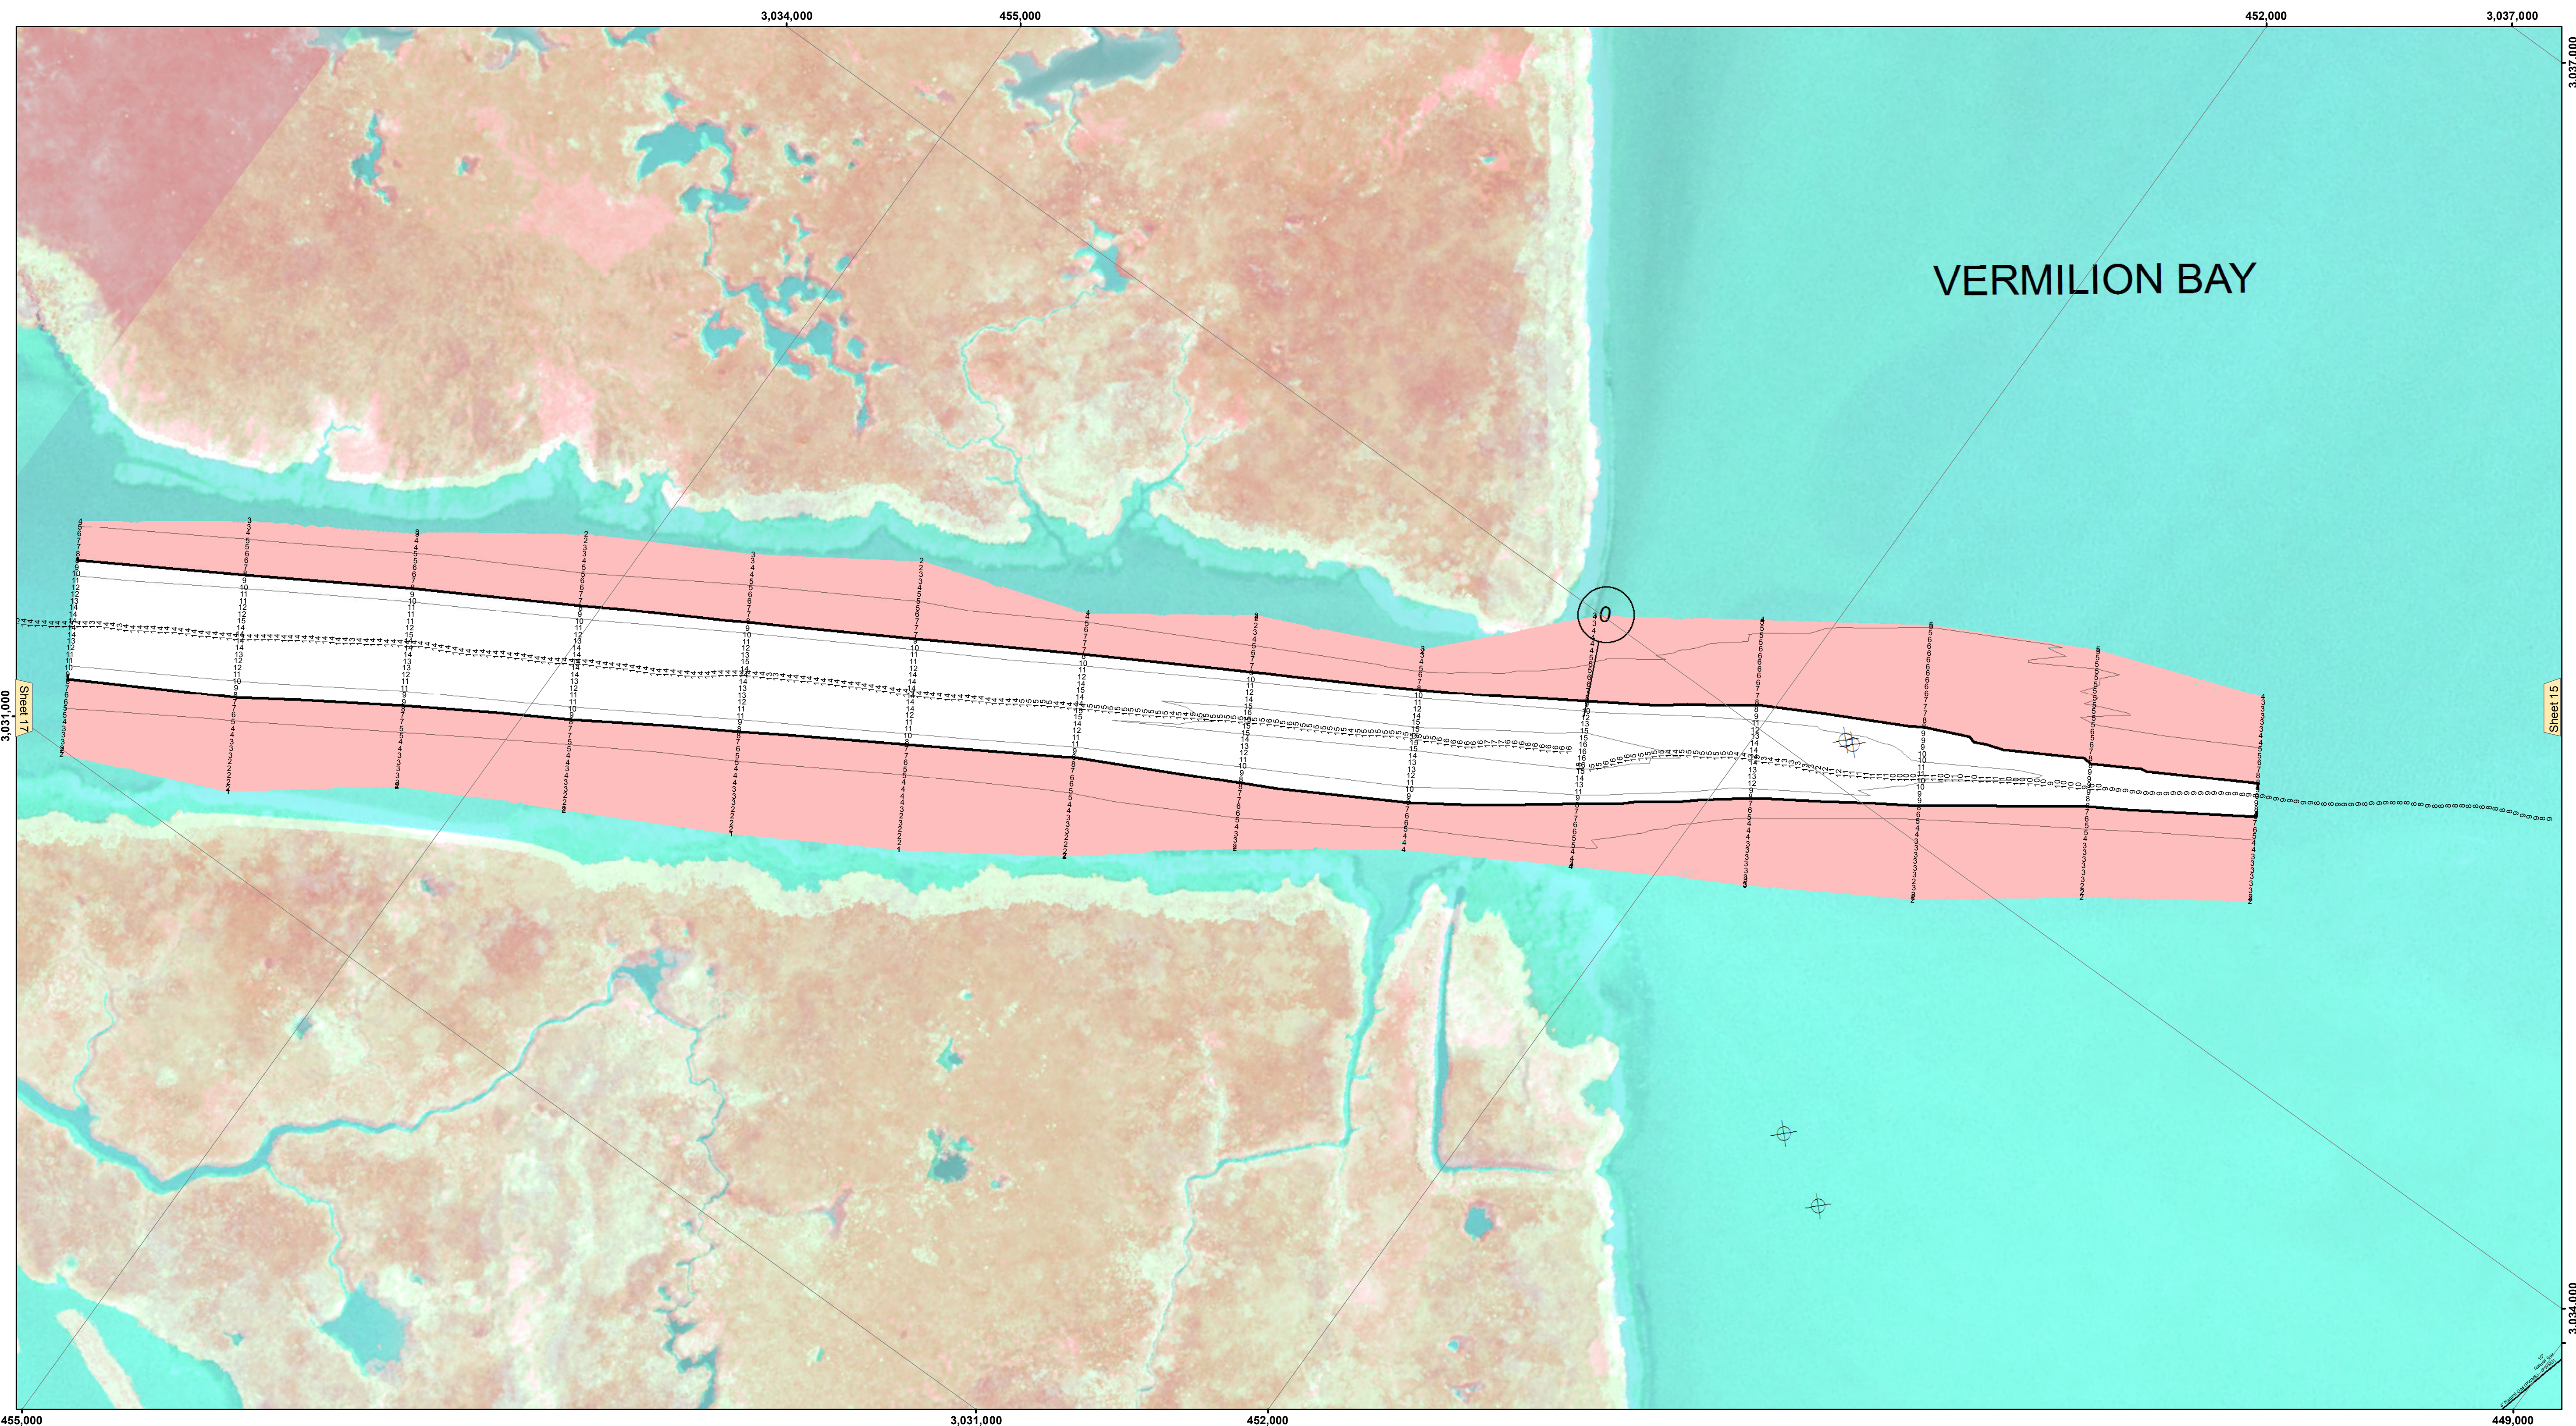
Gage Reading: LELAND BOWMAN E: 3.4 MLG AVG
Sea Conditions: CALM
Vessel Name: M/V OB 189
Survey Type: CONDITION
Sounding Frequency*:** HIGH

** Shoalest Sounding per Quarter per Reach.

*** High frequency (200 kHz) survey data represents the first signal return at a sounding location and will include suspended solids, known as "fluff", if present. Low frequency (20 kHz) survey data normally penetrates through this "fluff" layer to depict elevations of consolidated bottom material. Low frequency accuracies may vary depending on channel conditions and fathometer settings.
